**Figure 18.** Schematic of accident pipe.

### **1.8.1 Welds**

### 1.8.2 Crack Initiation

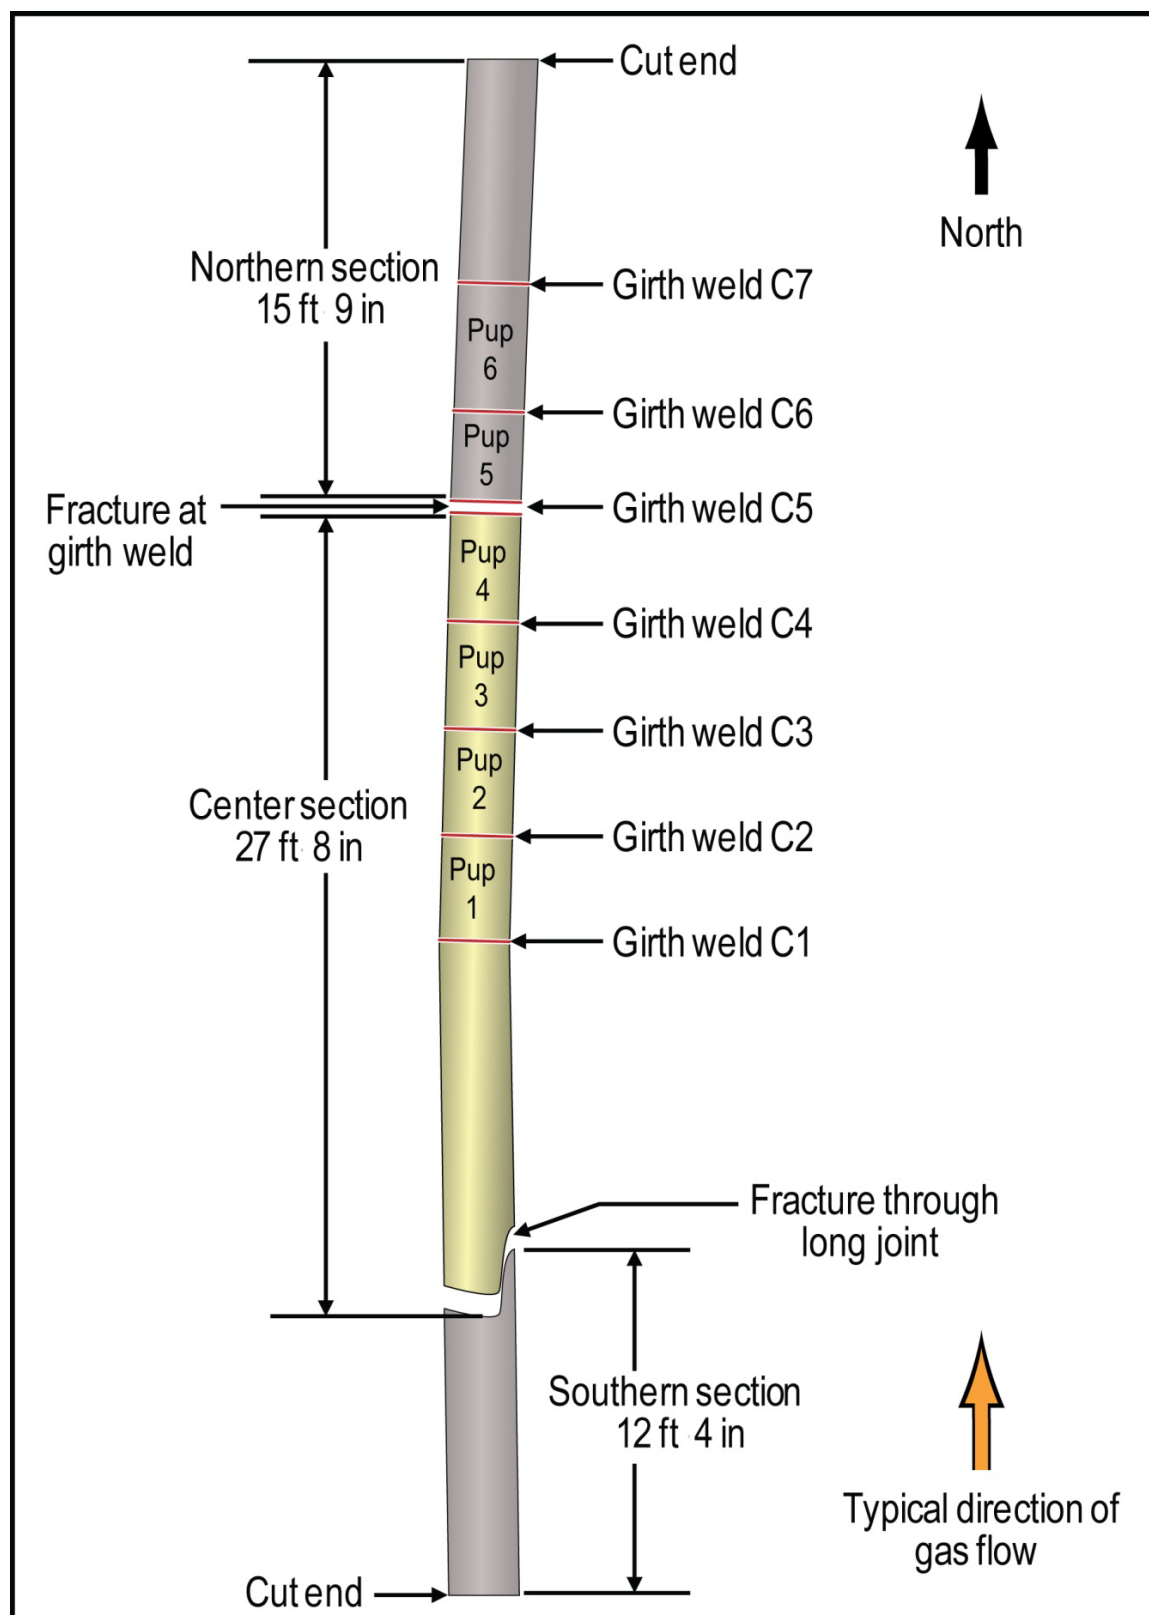
The length of pups 1–5 varied from 43.00–46.75 inches, and pup 6 measured 54.25 inches. All six pups were nominal 0.375-inch wall thickness pipe, as was the south long joint. However, the north long joint was nominal 0.312-inch wall thickness pipe. The pipe material codes on documents associated with the 1956 relocation project specified 0.375-inch wall thickness pipe. The circumference of each length of pipe was consistent with nominal 30-inch-diameter pipe.

There were no observed areas of preexisting external or internal corrosion on any surface of the pipe.

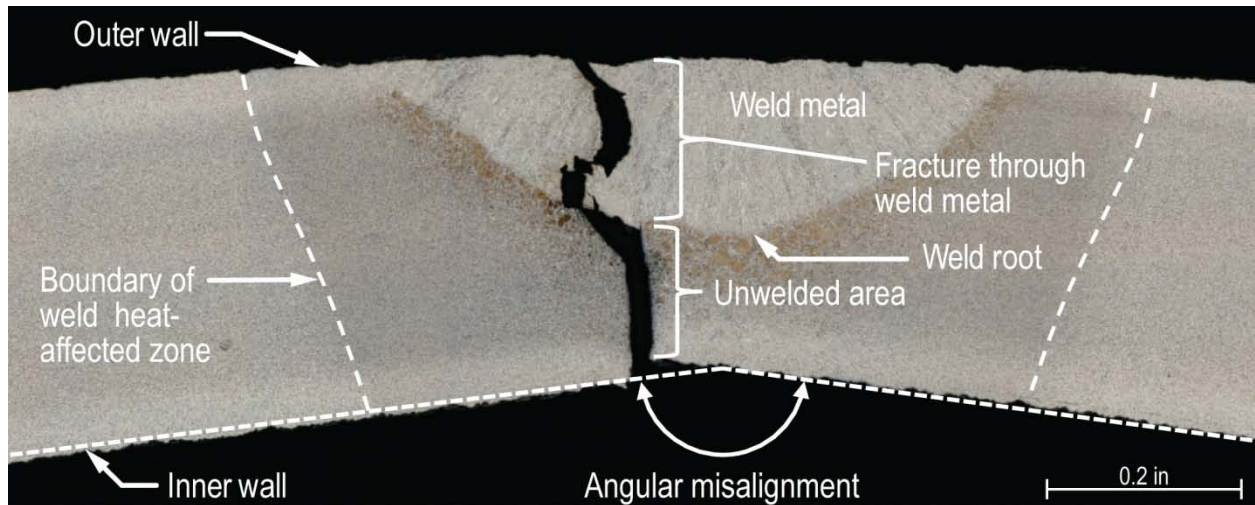
The longitudinal seam welds on pups 1–3 were fabricated using a fusion welding process that deposited weld metal along the outer portion of the seam, but left an unwelded region along the inner portion of the seam. (See figure 19a.) The weld reinforcement, as well as part of the pipe body for pup 1, had been removed by grinding. The unwelded region persisted along the entire length of each seam. The size of the unwelded region, combined with the grinding of the weld reinforcements (and the pipe body for pup 1), resulted in net intact seam thicknesses of 0.162, 0.195, and 0.162 inch for pups 1, 2, and 3, respectively. The unwelded region defect was observed during a visual weld inspection of each pup. As shown in figure 19a, there was a 15° difference in the orientation of the inner surface of the pipe across the pup 1 longitudinal seam (an angular misalignment). For pup 2, the difference was 0°; and for pup 3, the difference was between 7–10°.

**Figure 19a.** Picture showing cross section of longitudinal seam in pup 1.

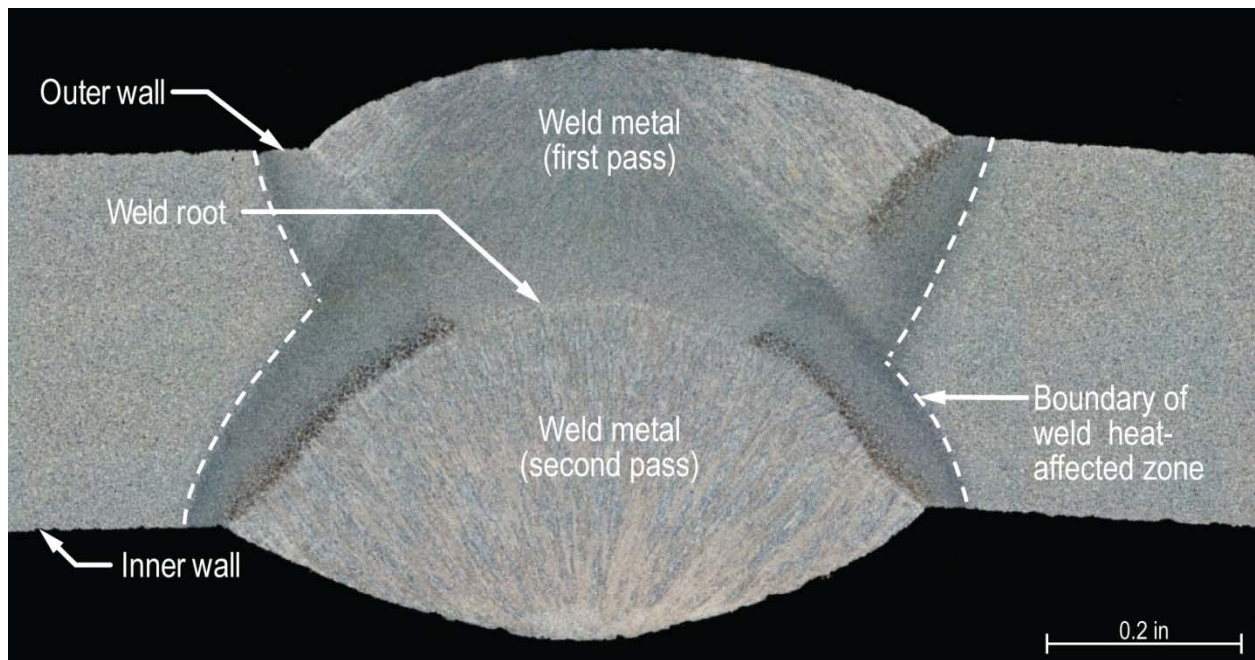
The south and north long joints, as well as pup 6, were standard factory-made DSAW pipe, made by a submerged arc welding<sup>65</sup> process on the outer- and inner-diameter surfaces. (See figure 19b.) The outer and inner weld passes overlapped, resulting in full penetration in the joint, and each weld exhibited a raised weld reinforcement with a smooth surface. No cracks or surface-connected defects were observed on the longitudinal seam welds of the DSAW pipe sections.

**Figure 19b.** Picture showing cross section of longitudinal seam in typical DSAW pipe.

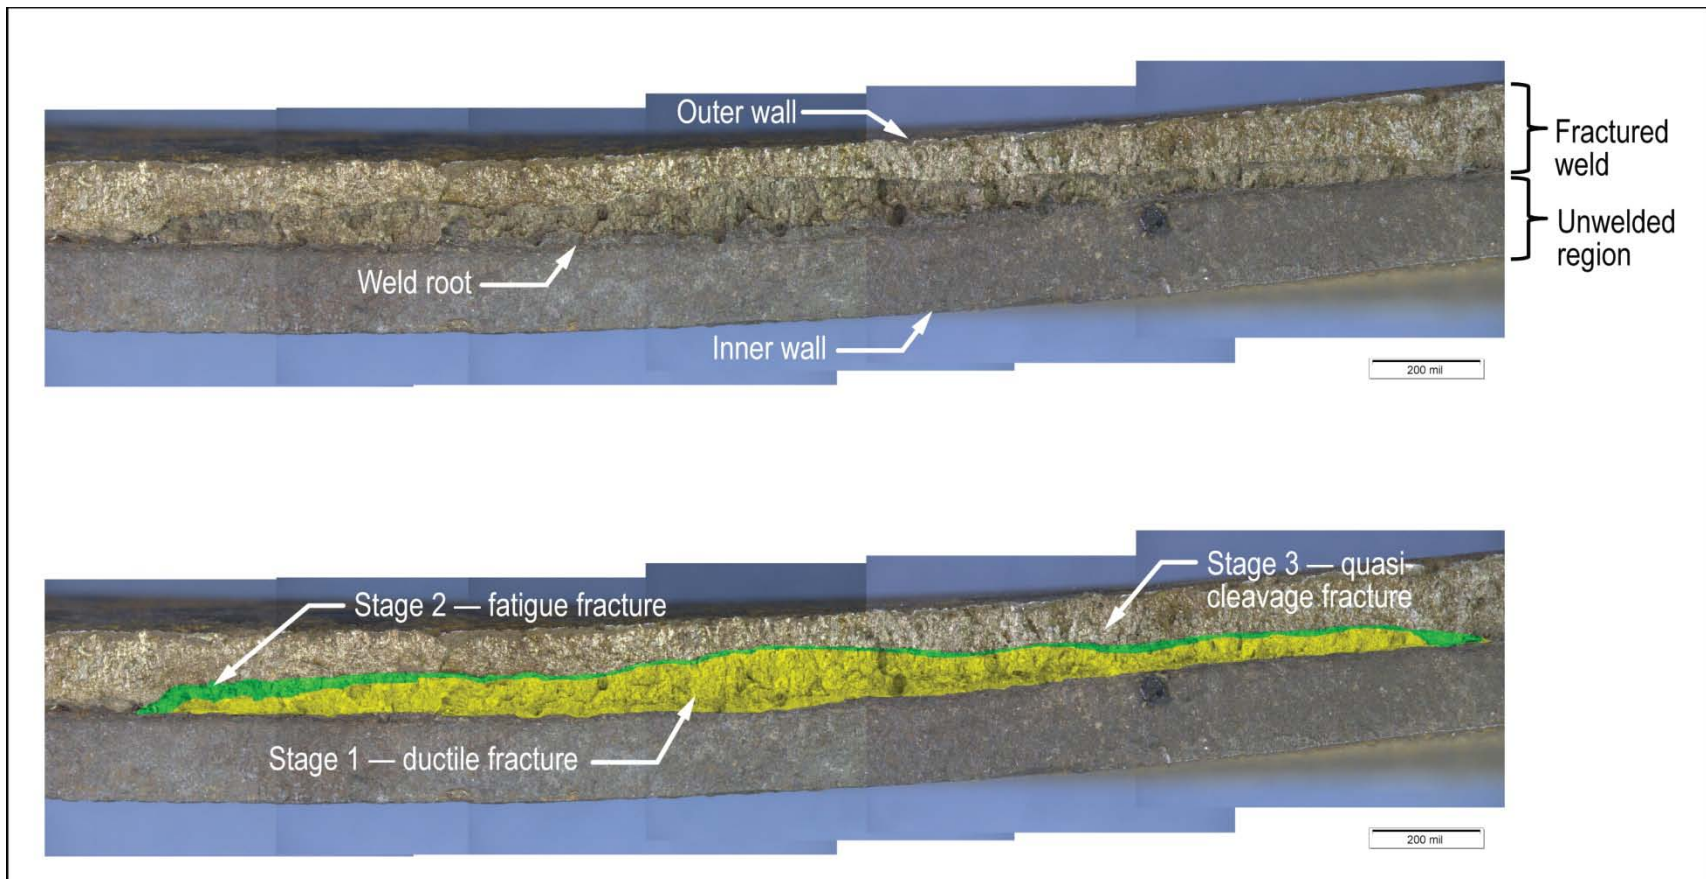
Fracture features in the center section of pipe were consistent with the rupture initiating at a preexisting 2.4-inch-long crack in the pup 1 longitudinal seam 20.3–22.7 inches north of the C1 girth weld (approximately mid-span). The direction of crack propagation is indicated by the white arrows in figure 20. Optical and electron microscope examination of the fracture initiation site indicated that the preexisting crack grew by two different modes prior to the rupture. (See figure 21.) The crack first grew by ductile fracture<sup>70</sup> starting at the root of the weld, reducing the area of the intact cross section, measured over the 2.4-inch-long initiation site, by approximately 33 percent (stage 1). It subsequently grew by fatigue fracture,<sup>71</sup> further reducing the area of the intact cross section by approximately 10 percent (stage 2). The ductile fracture and fatigue fracture regions are colored yellow and green, respectively, in figure 21. The fracture elsewhere along the seam was caused by the rupture (stage 3) and was primarily quasi-cleavage fracture.<sup>72</sup> Occasional small thumbnail-shaped fatigue cracks were observed elsewhere along the pup 1 weld root. The other pups with unwelded seam defects exhibited one or more ductile fracture

**Figure 21.** Pictures highlighting rupture initiation site in pup 1 longitudinal seam.

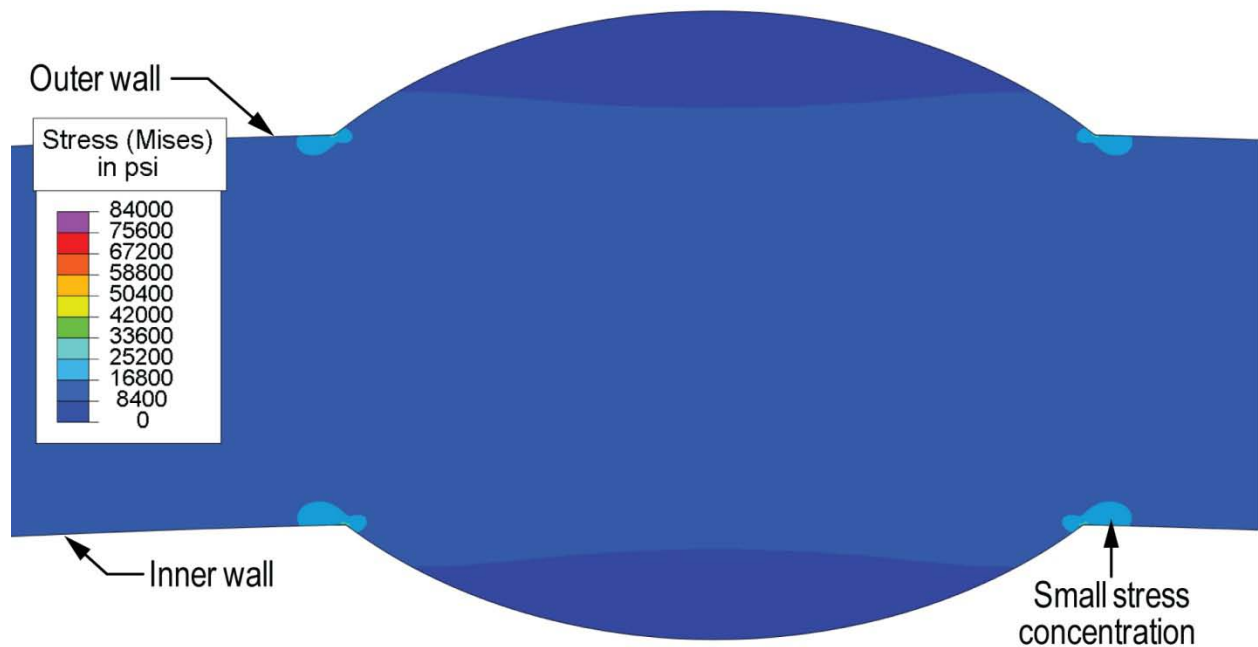
The model with the DSAW seam had small stress concentrations at the corners where the weld reinforcement intersected the wall of the pipe (on the order of 2 percent of the pipe wall thickness in size), but the stress in the model did not reach the yield stress. The unwelded region and angular misalignment in the model based on the pup 1 seam created a crack-like geometry (that is, notch) leading to a severe stress and strain concentration.<sup>85</sup> In that model, at 375 psig, the zone of material beyond the yield stress was on the order of half the pipe wall thickness in size. (See figures 22a and 22b.) The plastic strains<sup>86</sup> at the pup 1 notch tip were more than 100 percent greater than those of the pipe with the similarly sized weld defect but no angular misalignment. The plastic strains were also as much as 40 percent greater than those for the pup 3 weld geometry.

**Figure 22b.** Stress contours at an internal pressure of 375 psig for the finite element model of a DSAW seam. Contour values are the same as in figure 22a.
